# ACE

technical reference

## Common Inaccuracies of Point Grinding and their Effects

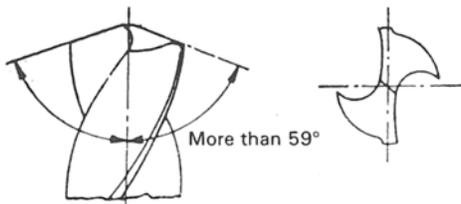
Fig. 2 Point Angle too Obtuse

**INCORRECT**

When the angle is ground much in excess of  $118^\circ$ , the cutting lips become concave or hooked. This weakens the outer corners and impairs the efficiency of the drill.

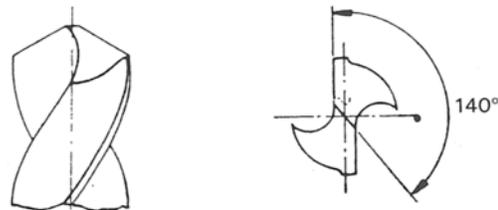
Fig. 6 Effect of Excessive Clearances

**INCORRECT (A)**

**INCORRECT (B)**

**(A) Initial:** This causes lack of support behind the cutting lips, and in consequence they may chip or break under normal feeds.

**(B) Chisel:** This is indicated by a chisel edge angle in excess of  $130^\circ$ . This causes the chisel edge to lengthen preventing the drill from centralizing properly. Oversized and out-of-round holes will be produced.
